# Conserving Herefordshire's Ice Age Ponds

August 2019

## Pond Survey and Management Plan

Pond F - Hedgerow Pond, Sturts  
South, Herefordshire Wildlife  
Trust Reserve

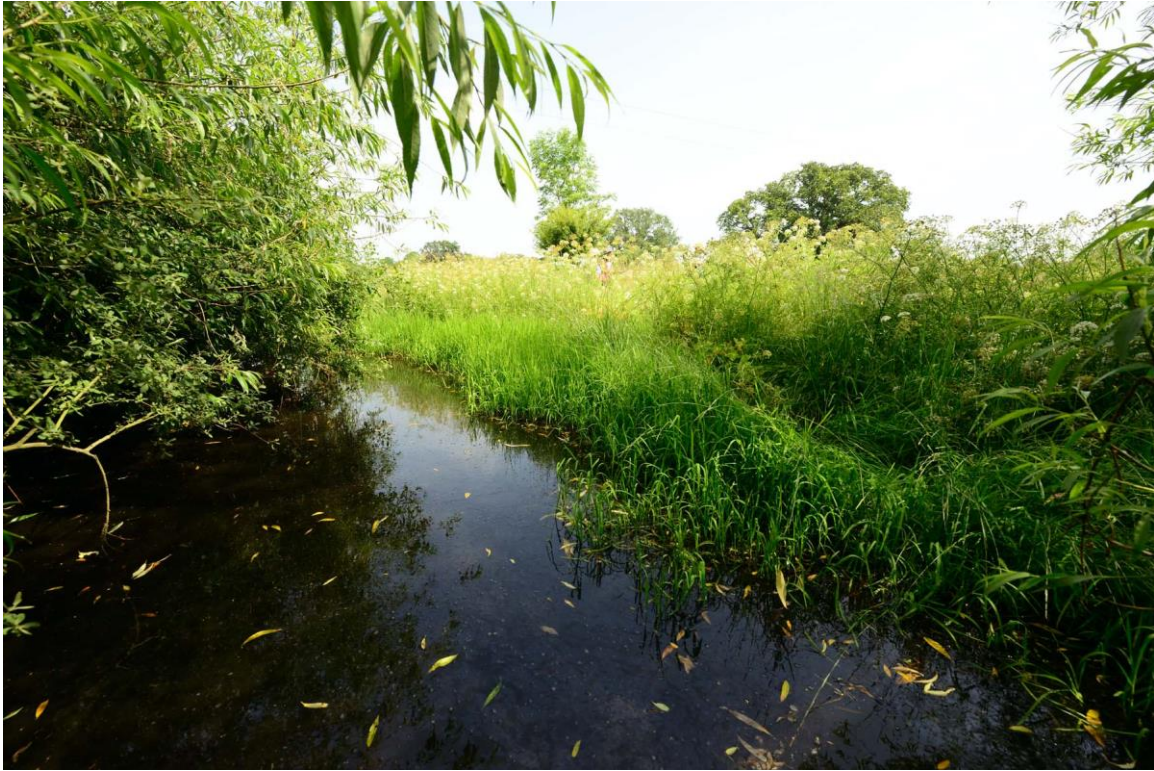
**Photo 1: The east margin with emergent flote-grass and Hemlock Water Dropwort beyond**

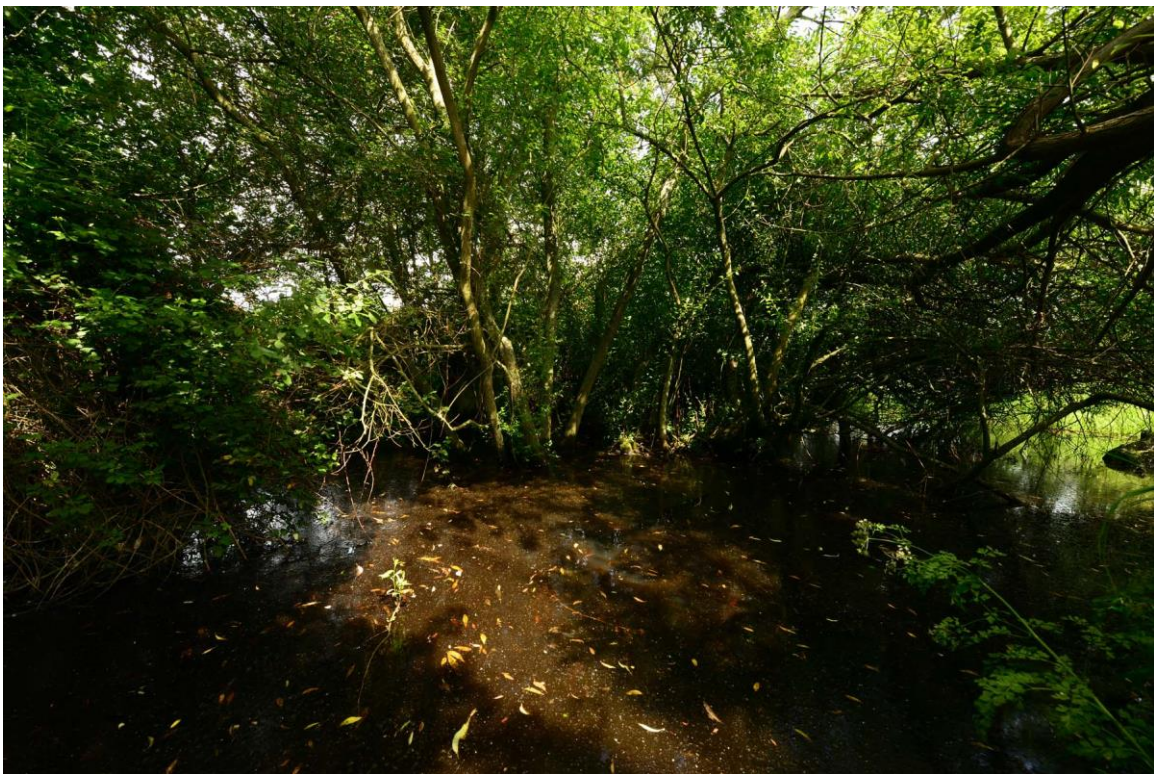
The pond is very shaded. This restricts its potential to support aquatic plants and their associated macro-invertebrate communities. Shade reduction would greatly improve the quality of this pond.

**Photo 2. Dense shade beneath the Grey Sallow canopy**

- Fell the three multi-stemmed Grey Sallows on the north side of the pond.
- Stems should be cut 15 cm above the pond surface. as shown on the plan and Photo 2
- All cut material should be removed from the pond, including small branches and twigs as they can easily regrow. The wood can be taken off site. Smaller branches and twigs could be chipped or burnt.

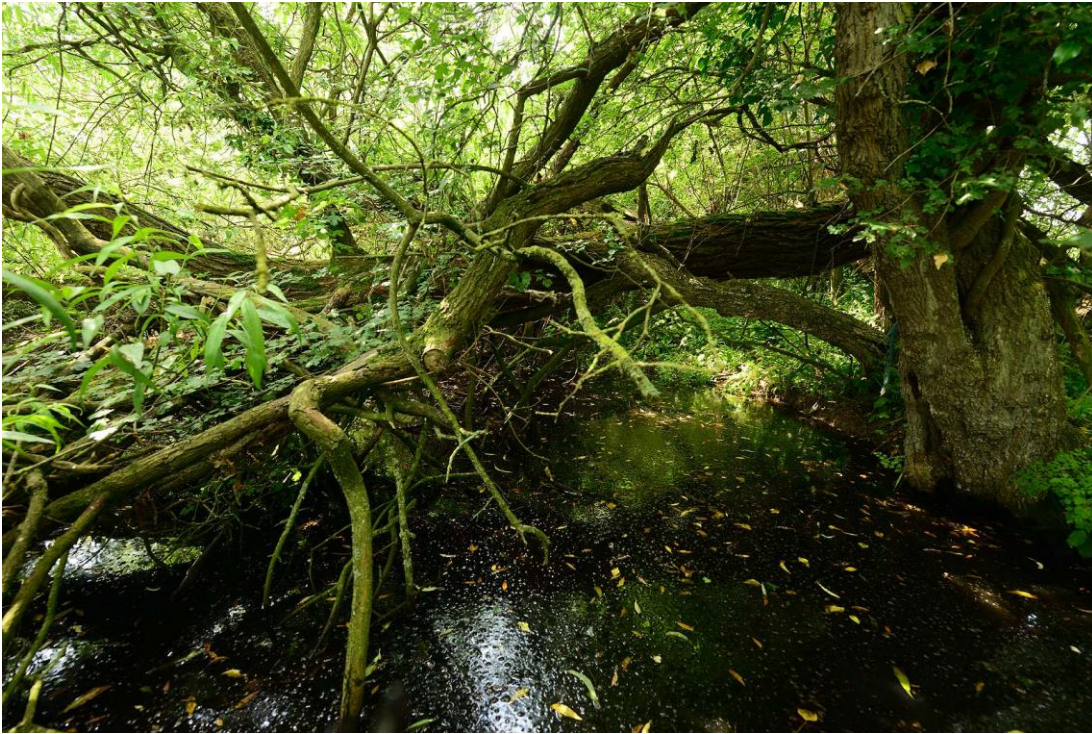
**Photo 3: The collapsed Crack Willow branch extending across the pond**

- Pollard the 2 split trunks of the collapsed Crack Willow pollard on the west side of the pond.
- Remove the Crack Willow branches which have collapsed across the pond (see Photo 3). The largest of these is 30 cm in diameter.
- Remove the small Crack Willow on the island in the middle of the pond.
- Remove the misshapen, collapsed Crack Willow on the east side of the pond. Felling above the water and then treating with herbicide may be the best option.
- Remove the young Crack Willow growing on the upper pond bank next to this tree (see plan).
- All cut material should be removed from the pond, including small branches and twigs as they can easily regrow. The wood can be taken off site. Smaller branches and twigs could be chipped or burnt.

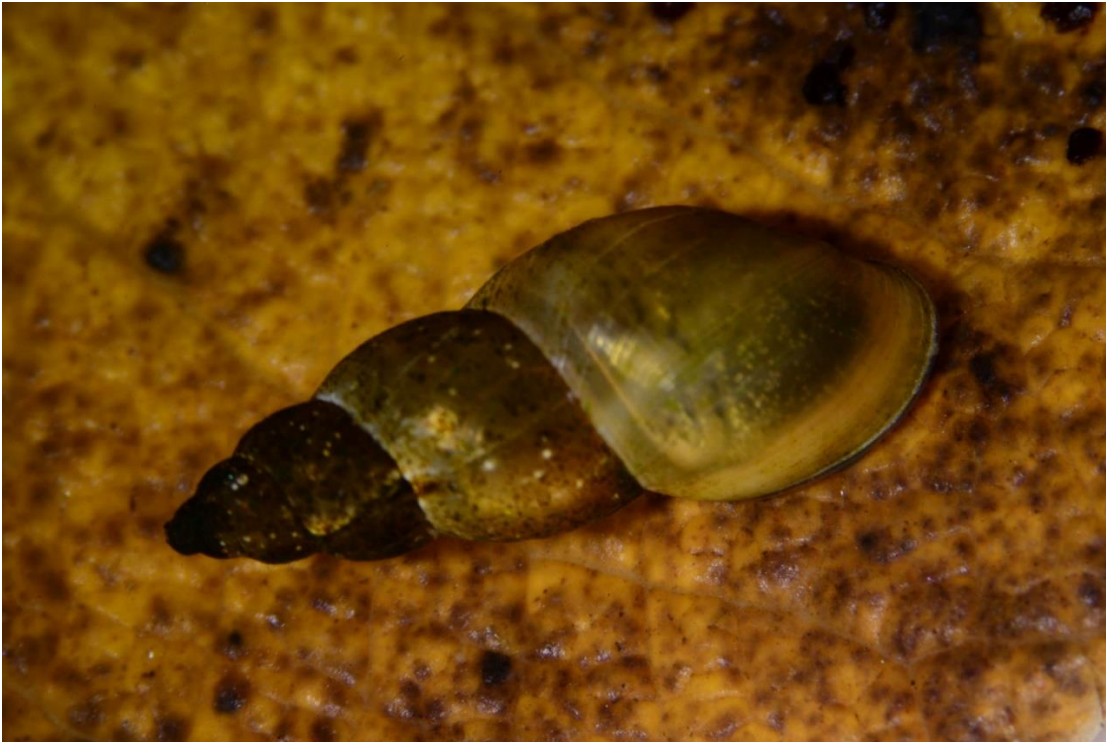
On 9<sup>th</sup> May **Mud Snail** *Omphiscola glabra* was recorded in Pond F (see Photo 4). It is now classified as Near Threatened by the **IUCN, Vulnerable** (formerly RDB") in the UK Red Data Book and is a Section 41 Conservation Priority Species under the UK BAP.

**Photo 4: Mud Snail from Pond F**
